# ENDURA-FLEX® EF-1988

"creative solutions for environmental concerns"

## Issues prior to coating

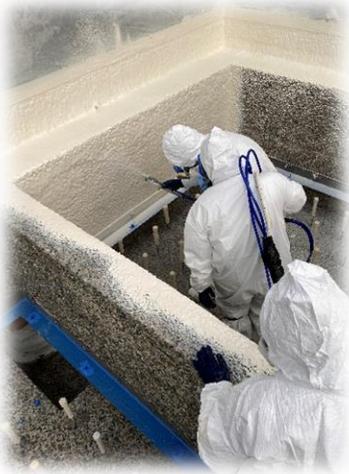
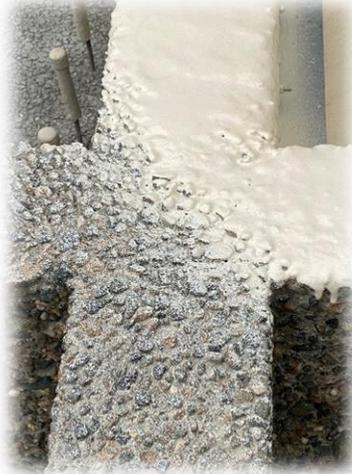
- ◆ Backwash hood not sealing properly during backwash due to rough and spalled concrete surface
- ◆ Losing filter media into underdrain plenum from gaps between stainless-steel underdrain support angle and concrete filter cell
- ◆ Loosing 1 million gallons of water a day thru cracks and concrete porosity in the floor of the filter basin during the filtering process

- ◆ Installed EF-1988 expanded and solid to create a flat and smooth sealing surface for the backwash hoods
- ◆ Coat the concrete filter cell and on-top of stainless-steel angle to create a monolithic coating system that eliminates the voids and media loss
- ◆ Coating floors and walls of filters eliminated water loss during filtering
